# Manhole Inspection Summary

Manhole # S35UU1019MH

**Location** Address: **305 BROADMOOR RD** Cross Street: **PADDINGTON RD**

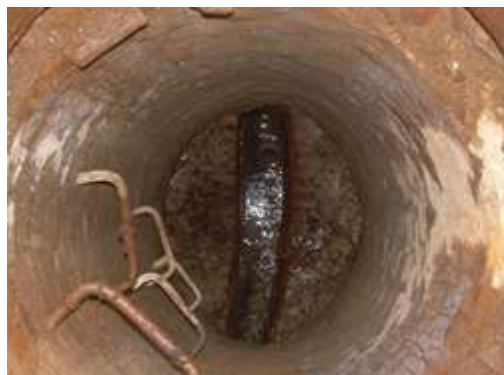
Top View

Corroded steps. Evidence of surcharge - Bench debris.

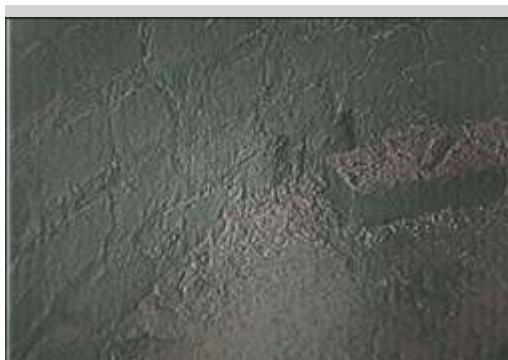
Defect

Barrel deterioration and infiltration.

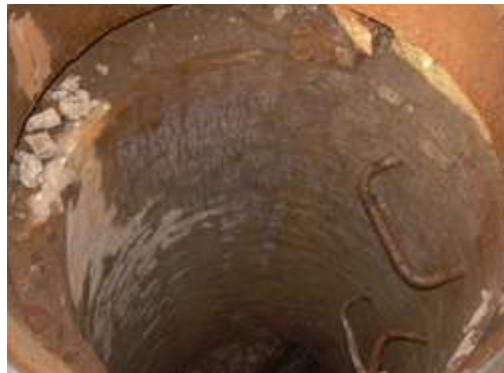
Defect

Frame offset. Frame leaks. Adjustment deterioration, loose brick and infiltration. Corbel and Barrel infiltration.

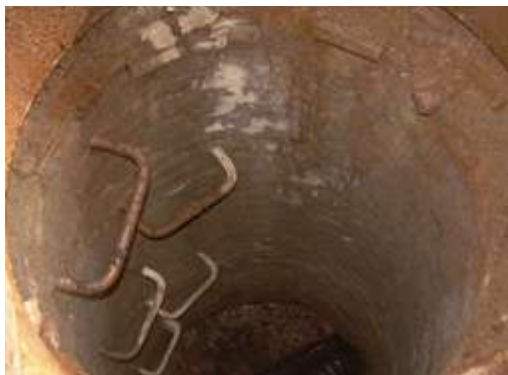
Defect

Frame leaks. Frame offset. Adjustment deterioration, loose brick and infiltration. Corbel and Barrel infiltration - other side.

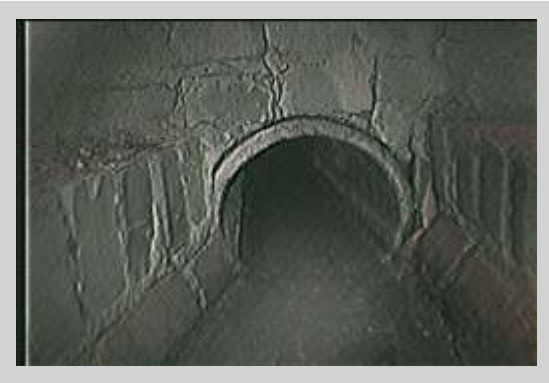
### 8 in. Circular Gravity Sewer Pipe Out @ 12 O'Clock

Comments **The O12 pipe seal is not flush to the pipe.**

Barrel deterioration and infiltration. Channel deterioration.

Deposits: ☐ None ☒ **Mud** ☐ Sludge ☒ **Debris** ☐ Grease

Infiltration: **Evidence** Pipe Seal Cond: **Cracked**

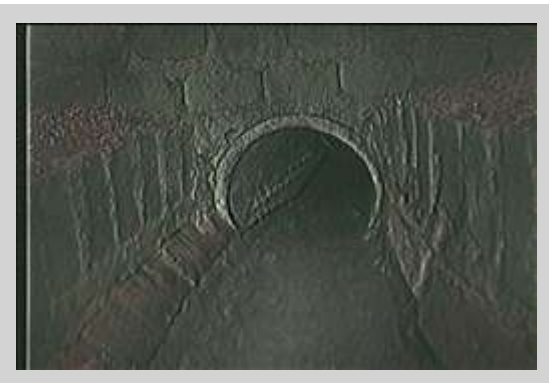
### 8 in. Circular Gravity Sewer Pipe In @ 7 O'Clock

Barrel deterioration and infiltration. Channel deterioration.

Deposits: ☐ None ☒ **Mud** ☐ Sludge ☒ **Debris** ☐ Grease

Infiltration: **Evidence** Pipe Seal Cond: **Unknown**
